Reconnaissance Report of Boundary Fences on New Lands, Navajo Nation

Office of Navajo-Hopi Indian Relocation

April 30, 2014

NEW LANDS FENCING ASSESSMENT OF PERIMETER AND SELECTED INTERIOR SECTIONS

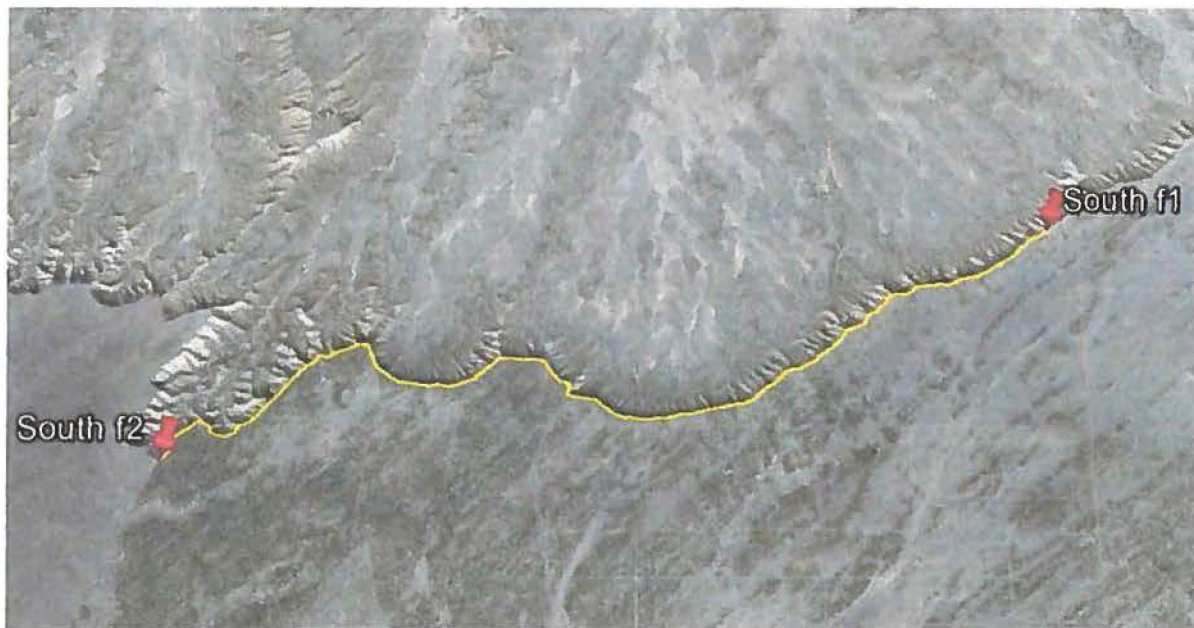
1. The southern boundary of Rim and East Well units are bounded by an escarpment, which presently forms somewhat of a deterrent to use by livestock. However, the area is subject to use by wild ungulates and horses through existing trails that permit access across the boundary. Fencing is recommended to reduce the risk of entry by feral livestock and other private stock from neighboring ranches (Figures 2-5). Fences of the southern boundary are relatively new and in good condition.

Figure 2. Relative approximation of the location of boundary fence along the escarpment. Approximate distance is 6.1 miles following escarpment or 5.25 miles in larger linear increments.

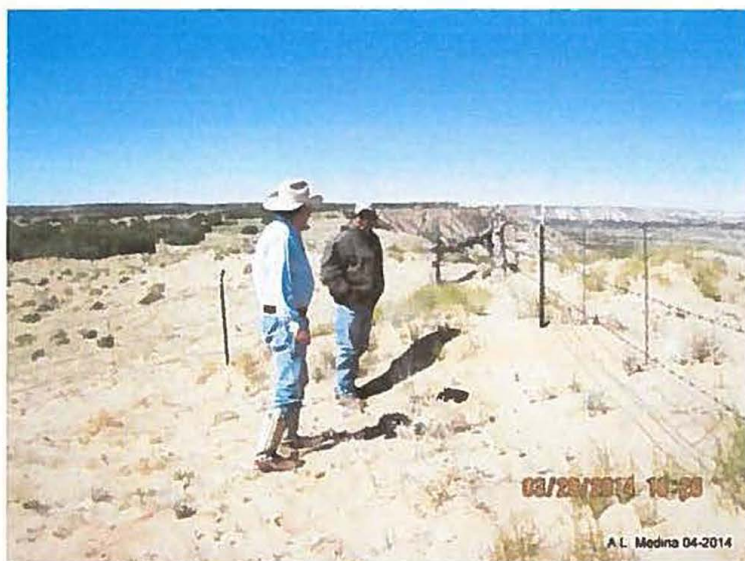
Figure 3. This photo shows the existing corner on the east side of the escarpment.

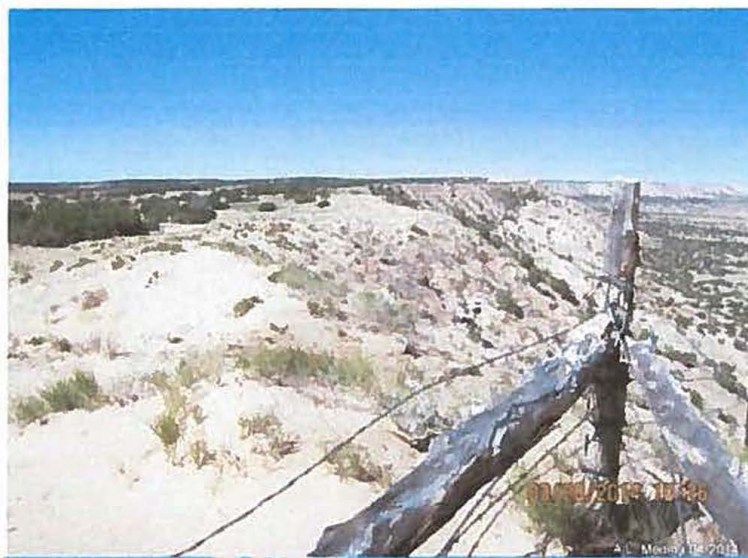
Figure 4. This photo shows the westerly view of the approximate location of the boundary. The boundary is seemingly the rim edge of the escarpment. There are existing roads for access.

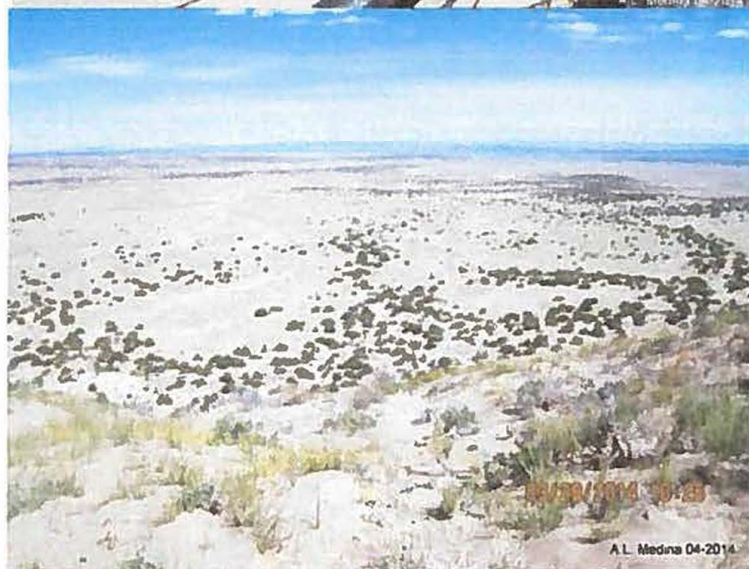
Figure 5. This photo looks north from the escarpment and illustrates the relative ease with which feral and trespass stock can access News Lands.

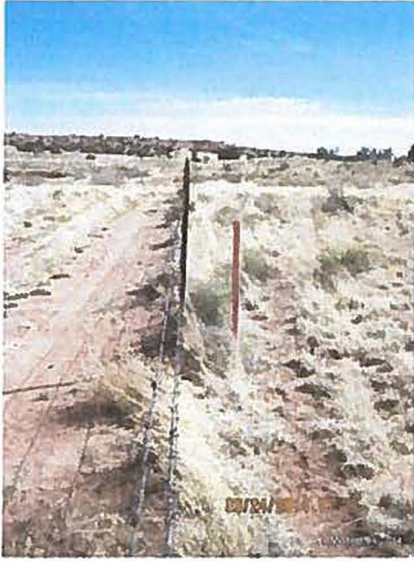
6. The north boundary fence of Padres Mesa is new and in good condition. A couple of locations had broken upper strands where elk had jumped. Recommend installing elk jumps at these and other similar locations where elk have demonstrated a preference for crossing. The replacement of boundary fence appeared unnecessary given that boundary discrepancies were minor and insignificant considering it's all Navajo Nation lands. In some cases the discrepancies were inches different (Figures 6-9). There were several areas where the tractor blade made close contact with the fence posts, thereby

Figure 6. This photo shows the fence realignment discrepancy on the north fence of Padre Mesa.

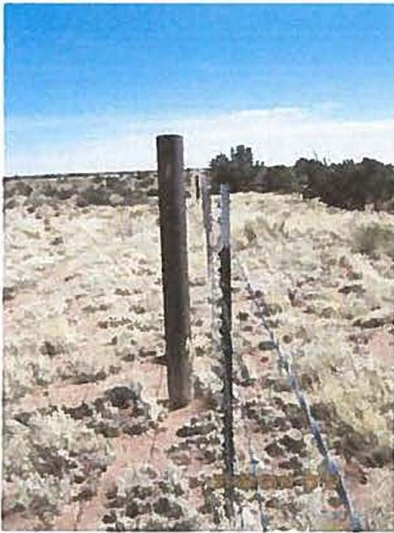
Figure 7. This photo shows another section of fence that was realigned, seemingly to minor alignment differences.

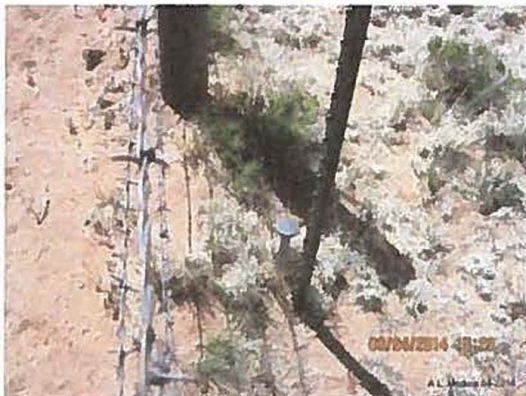
Figure 8. This photo shows the USGS boundary marker, the proposed realignment and the existing fence line.

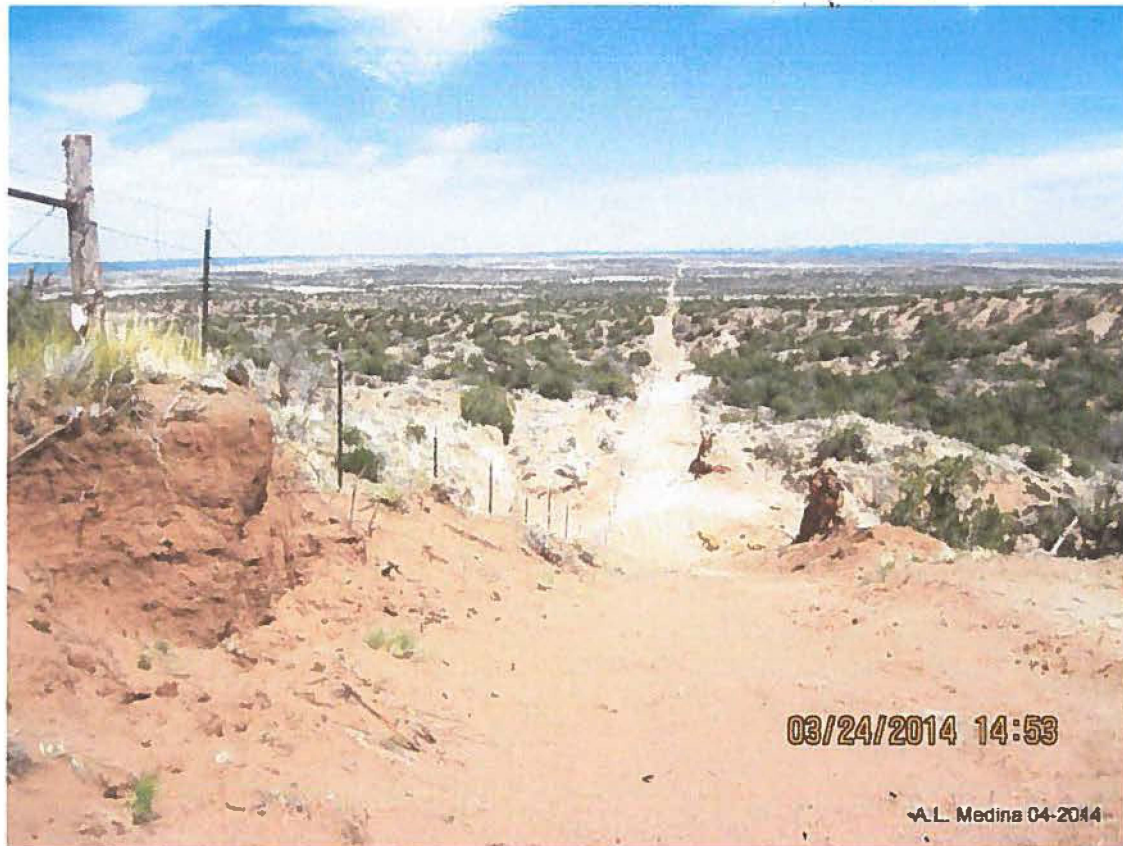
weakening their footing and likely will need reinforcement or replacement in very near future.

Figure 9. This photo shows the bladed area where the fence was realigned. The action resulted in several areas where the blade made too close contact with the fence and compromised their footing.

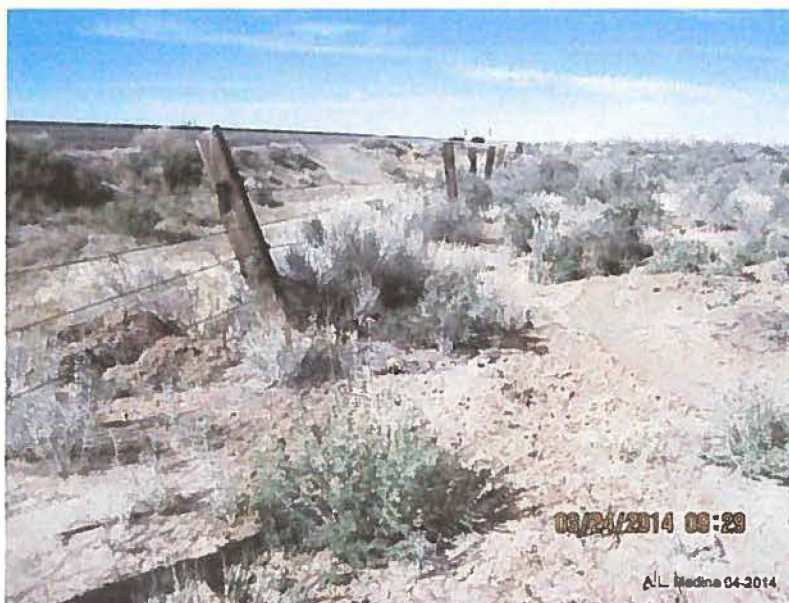
Interior boundary fences of New Lands are intact and in good –fair condition, with minor exceptions where treated posts need to be replaced or older wooden posts remain (Figure 10). In some localized areas, fences have sections where old wooden stays were used and could be replaced as part of a regular maintenance plan. Exceptions to the rule are listed below.

Figure 10. This photo shows a historical fence where railroad ties were used as line posts. These are rare on New Lands.

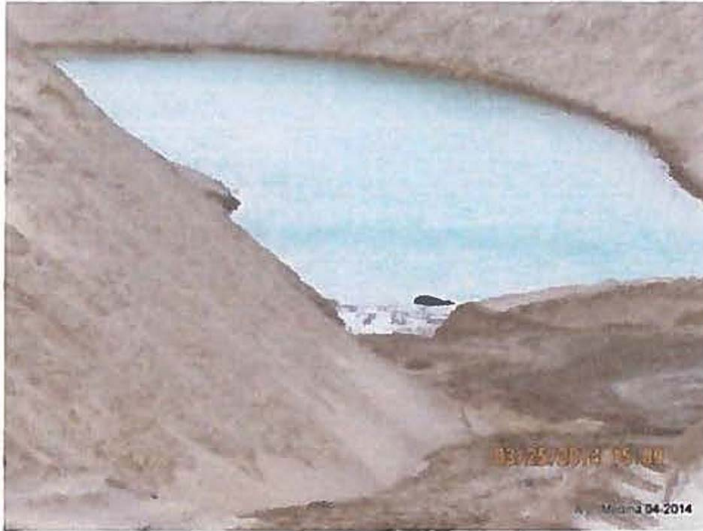
1. Clay Mine (Figures 11-14) – This area is outlined in red to bring attention to the priority need to provide a security fence that both excludes livestock and human entry. The entire mine areas, both north and south of Clay Mine Road, should be secured likewise. This area is a high risk-high danger area. Recommendations include high security perimeter fencing coupled with locked access gates on the east and west entry points. The fence breach on the eastern flank presents an immediate high risk to livestock, and inhibits use by the operator. An updated restoration and management plan by the mine owners should reflect the protective measures to protect human, animal and natural resources of the immediate area.

Figure 11. This photo shows the presence of a (drowned) cow that entered from the east side unto the mine area. The fence is entirely absent and submerged under overburden.

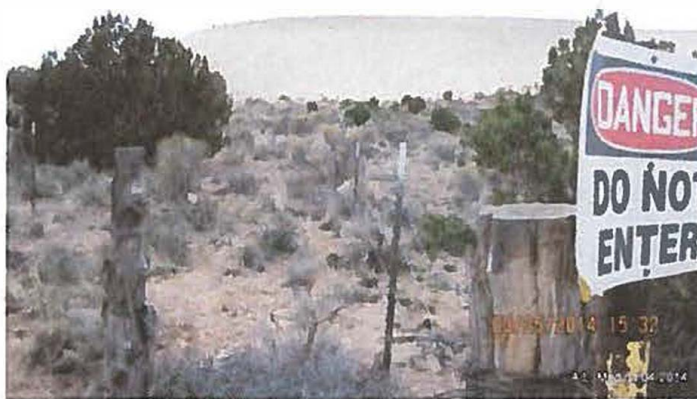
Figure 12. This view of the mine shows the limited signing and security fencing.

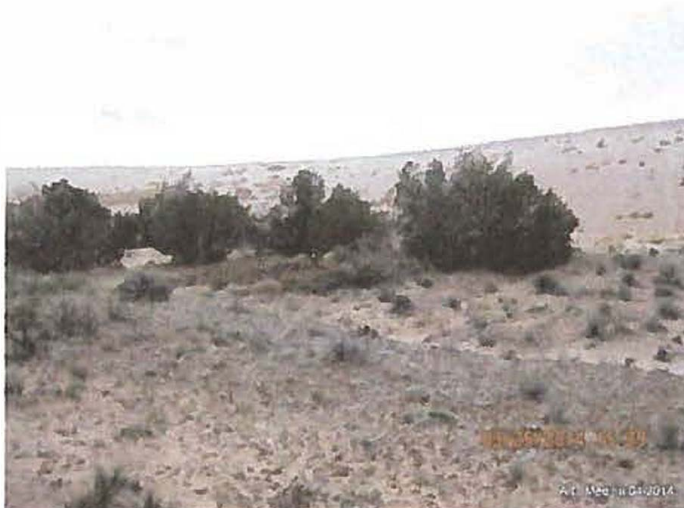
Figure 13. This photo shows the overburden that continues to migrate easterly and encroach upon New Lands.

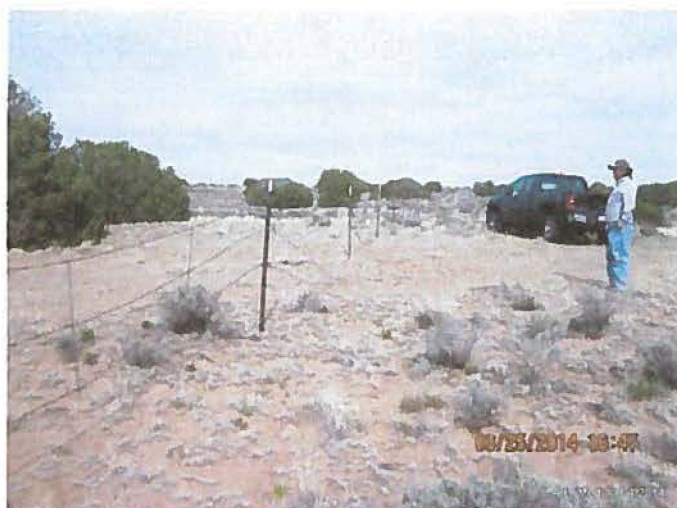
Figure 14. This photo shows cut fence line in Middle well. This location is indicated on Figure 1.

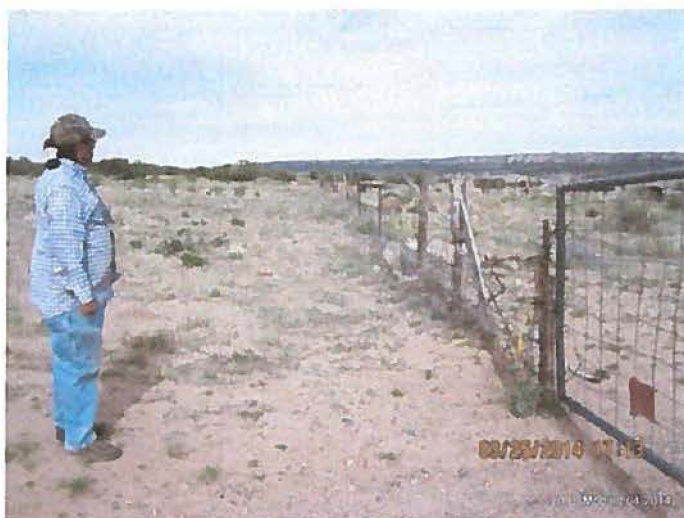
3. Encroachment appears to a problem in the community indicated in Figure 1. There a 3 instances where homeowners have placed corral inside the interior boundary fence. In addition, there a 2 presumably unauthorized roads that provide expedient access outside the community boundary using the range roads (Figures 15-17).

Figure 15. This photo shows the deteriorated condition of the fence around the community at Middle Well.

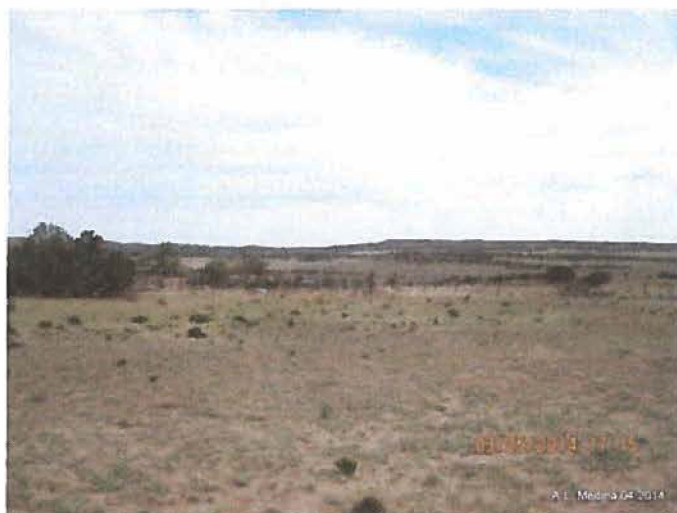
Figure 16. This photo shows 1 of 3 corral units presumably outside the community boundary. Other corrals are on the north boundary.

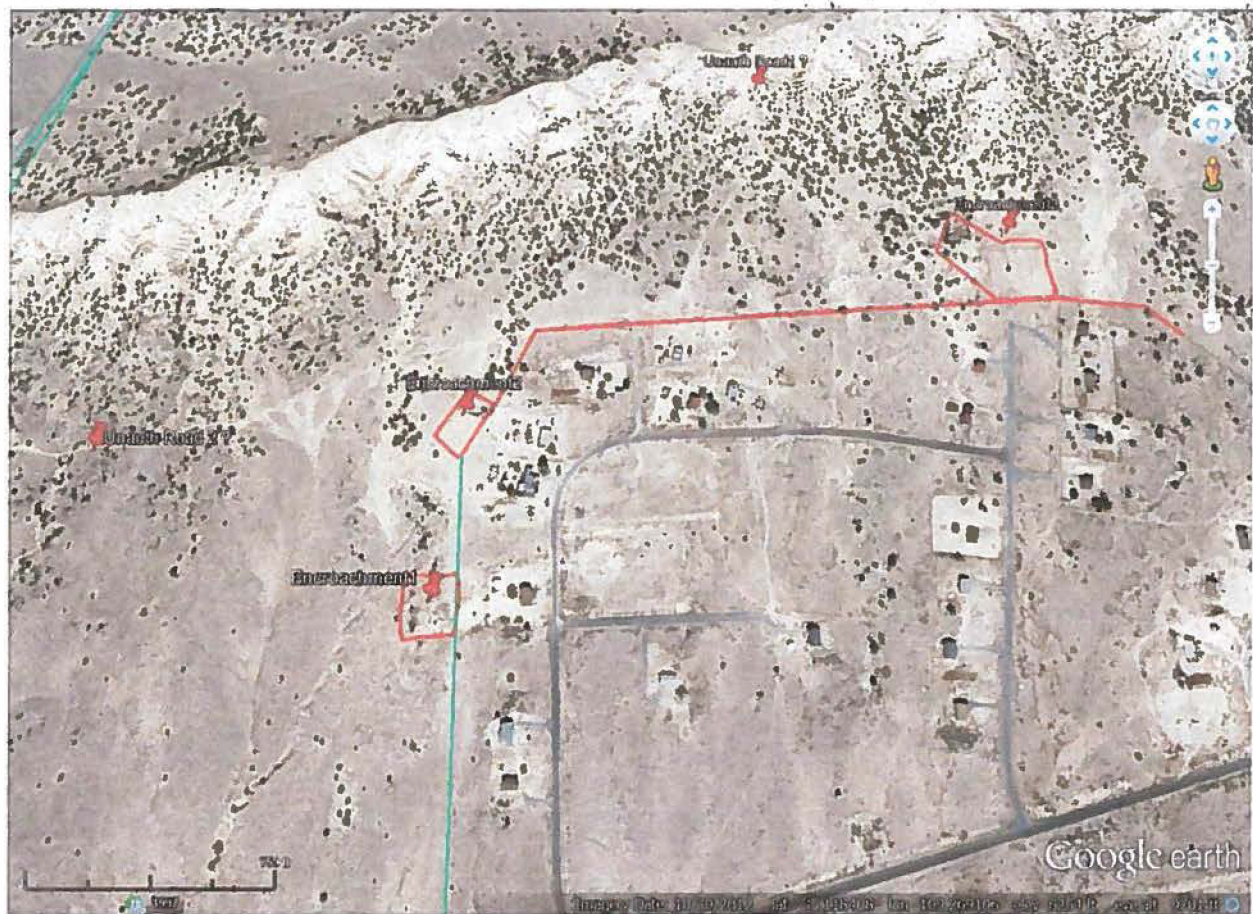
Figure 17. This photo shows the presumed encroachment locations around the west and north sides of the subdivision.
